Reliability, Availability, and Maintainability Testing of High Pressure Pumping Units for Mobile Army 600 Reverse Osmosis Water Purification Unit

by Wayne W. Sharp, Howard K. Bell Consulting Engineers, Inc.

Final report

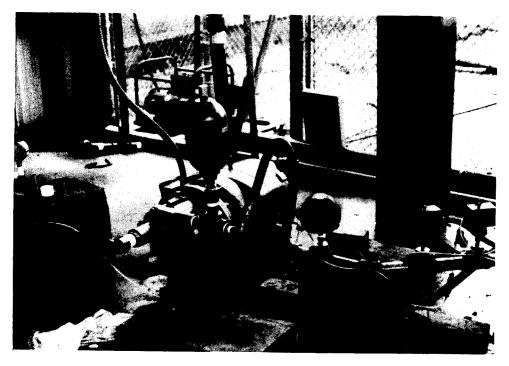
Figure 5. Sundstrand pump (Greer 4-qt damper)

c. Sundstrand Pump (Figure 5).

(1) Pump was disassembled very easily in accordance with the manufacturer's off-the-shelf manual. Compared with the positive displacement pumps, there are less moving parts, and disassembly/ reassembly was easier.

- (2) No rust was apparent internally or externally.
- (3) Entire pump unit (as a whole) was easily removed.
- (4) Impellers, gears, and exterior of the pump were in excellent shape.
- d. Ingersoll-Rand (Hammellman) Pump (Figure 6).
 - (1) Pump was easily disassembled in accordance with the manufacturer's off-the-shelf manual.
 - (2) No rust was apparent on internal or external surfaces.
 - (3) A slight tear was apparent in the center cylinder rubber packing.
 - (4) Crankshaft was difficult to access—motor was removed to access.
 - (5) Packings, valves, pistons, belts, coupling, driver, and exterior of the pump were in good condition.
